## Liverpool Library.

We were contacted by a major contractor to restore two glass ceilings within the Liverpool Library.

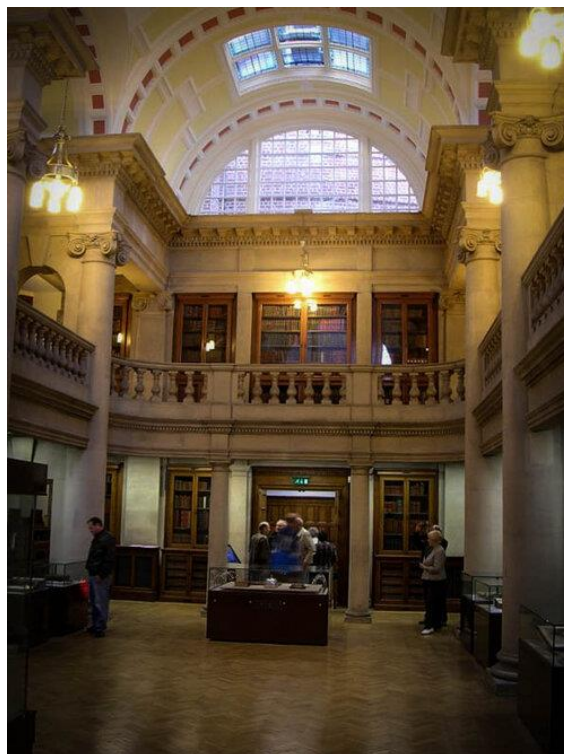
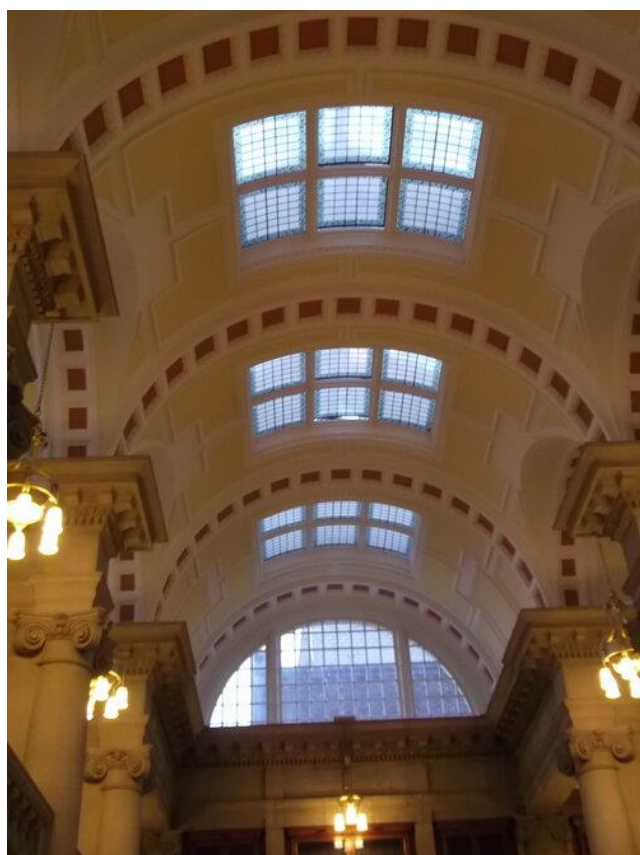
One was a traditional leaded glass ceiling that comprised of six panes of curved glass glazed into wooden frames of which there were five giving a total of thirty lights for restoration. This is located in the Hornby room. Some of these were in a very poor condition and in great danger of falling potentially causing a great deal of damage and possibly injury. They were also in need of a thorough clean as it appeared that the last time any one had been in the void above them was during

This project involved working at a great height and obviously health and safety was a major concern. All our workers carry CSCS cards and in this case we would not have been allowed to work without them. After all safety induction processes were complete we were able to inspect the lights closely for the first time. We were pleased to advise that due to the method of installation we would be able (at no extra cost) to remove the wooden sub frames and complete the removal of the leaded lights back in our workshop. This was not only safer but enabled the frames to be more thoroughly restored by another contractor before we refitted the glazing.

As part of the contract we carefully photographed each panel before dismantling and made careful note of any glass that needed to be replaced. Having supplied samples for approval prior to starting the work, we were able to get on with the careful restoration of the leaded lights bringing them back to their former glory.

All steel work was blast cleaned and powder coated and the steel subframes of the ventilated panels repaired and similarly refinished before reinstallation.

We were able to devise a method of fixing these frames securely to the wooden sub frames to prevent the situation arising again where by there was a danger of the panels falling out.
