## Liverpool Library.

We were contacted by a major contractor to restore two glass ceilings within the Liverpool Library.

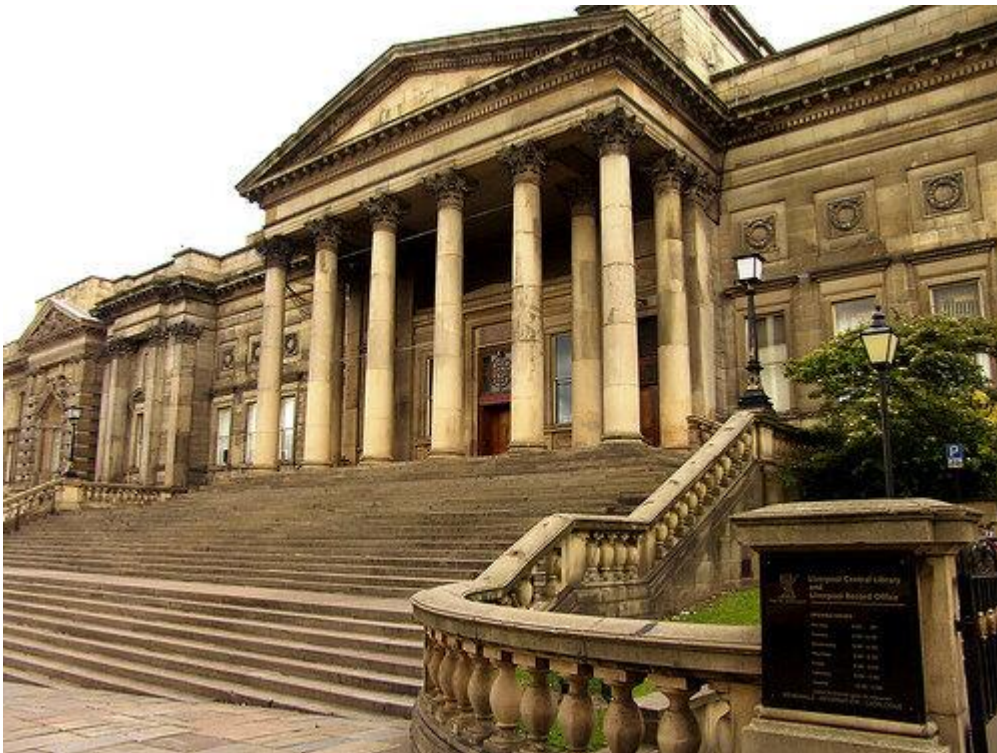
One was a traditional leaded glass ceiling that comprised of six panes of curved glass glazed into wooden frames of which there were five giving a total of thirty lights for restoration. This is located in the Hornby room. Some of these were in a very poor condition and in great danger of falling potentially causing a great deal of damage and possibly injury. They were also in need of a thorough clean as it appeared that the last time any one had been in the void above them was during

the Second World War – this was evidenced by the galvanised sand buckets for extinguishing incendiary bombs!

As part of the contract we carefully photographed each panel before dismantling and made careful note of any glass that needed to be replaced. Having supplied samples for approval prior to starting the work, we were able to get on with the careful restoration of the leaded lights bringing them back to their former glory.

All steel work was blast cleaned and powder coated and the steel subframes of the ventilated panels repaired and similarly refinished before reinstallation.

We were able to devise a method of fixing these frames securely to the wooden sub frames to prevent the situation arising again where by there was a danger of the panels falling out.
